Flood Control Project Maintenance
2014 Structure Summary Report
Overall Unit and Item Ratings

DWR Sutter Maintenance Yard

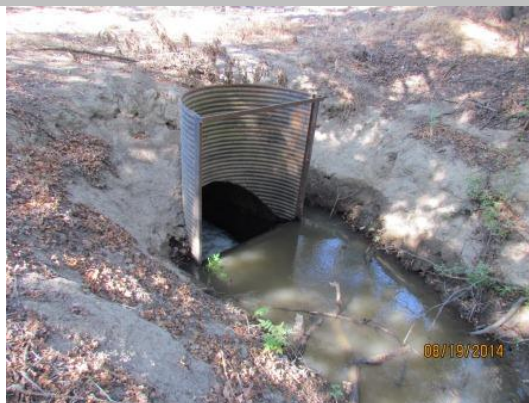
Photo 4 of 4 : ST_2014_NA0060_38_1_20140825_00007.jpg

Butte Slough Drainage structure on the land side.

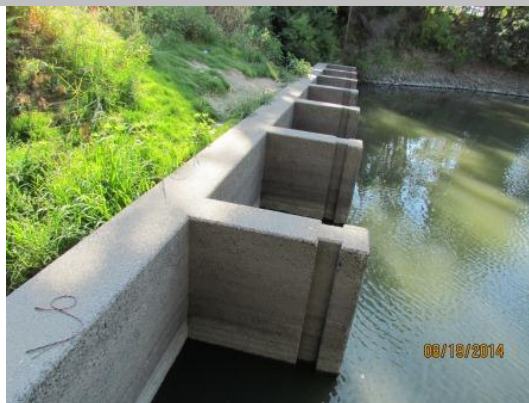
Photo 4 of 4 : ST_2014_NA0060_42_1_20140825_00006.jpg

View of the stop log slots on the water side.

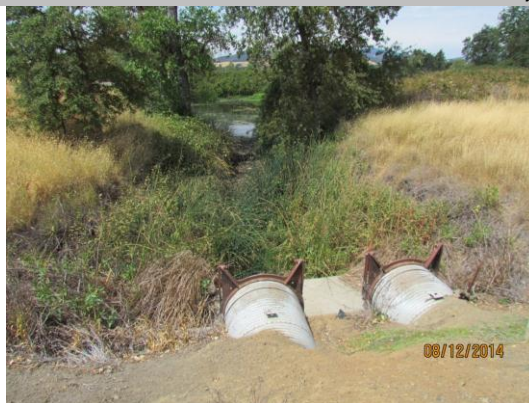
Photo 2 of 3 : ST_2014_NA0060_7_2_20140818_00016.jpg

View of vegetation on the outlet of the structure.

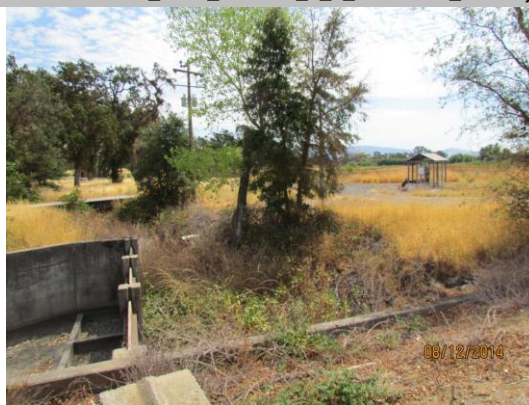
Photo 3 of 3 : ST_2014_NA0060_7_2_20140818_00024.jpg

Another view of the vegetation on the inlet of the structure.

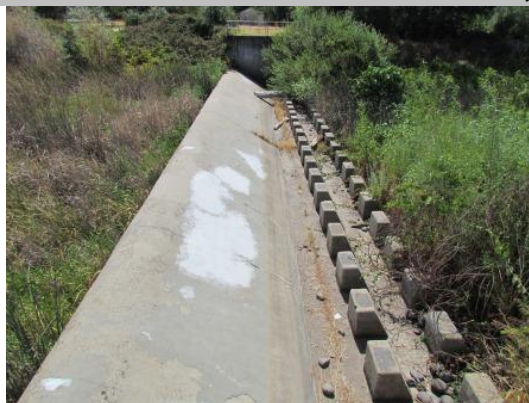
Photo 4 of 4 : ST_2014_NA0060_9_1_20140721_00011.jpg

This is a picture of the weir.

LM Start	0.00	Rating **	M	Issue No.	2
LM End	0.00	Issue Type +	Ma	Location *	
Category	Structures & Concrete Lined Channels			GPS Latitude/Longitude	
				Start	End
Item	Vegetation & Obstructions			39.733767 °	39.733767 °
				-121.771915 °	-121.771915 °
DWR ID	DWR_NA0060_9_t_2012_2				
Action/Comments					
Inspector Comments: There is some vegetation, a few small trees, and some debris on the weir. The flow may be impeded.

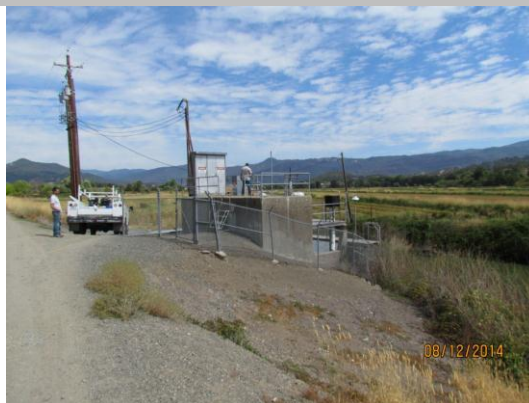
Photo 1 of 2 : ST_2014_NA0060_17_3_20140819_00018.jpg

LM Start	0.00	Rating **	M	Issue No.	3	
LM End	0.00	Issue Type +	Ma	Location *		
Category	Pump Stations			GPS Latitude/Longitude		
				Start	End	
Item	Plant Building			39.142300 °	39.142300 °	
				-122.902350 °	-122.902350 °	
DWR ID	DWR_NA0060_17_t_2012_3					
Action/Comments						
Inspector Comments: The plant building was in good structural condition with no major cracks that could threaten the integrity of the building. However, the adjacent structure had some differential settlement.

View of the pumping plant.

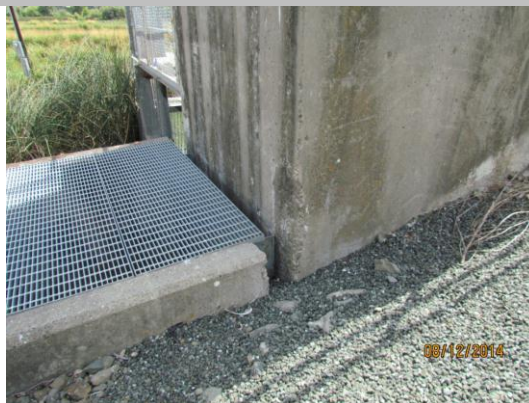
Photo 2 of 2 : ST_2014_NA0060_17_3_20140819_00019.jpg

View of the settlement next to the pumping plant.

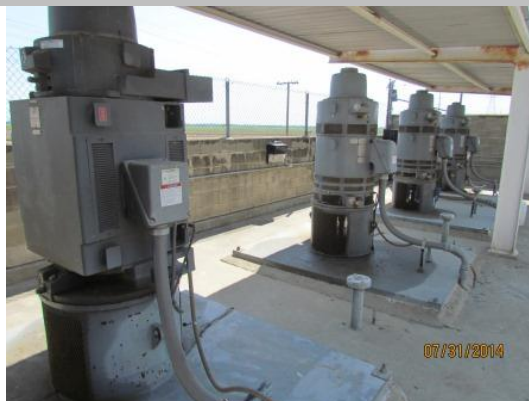
Photo 1 of 1 : ST_2014_NA0060_21_10_20140731_00014.jpg

Photo shows pump motors, which appear to be in operating condition.

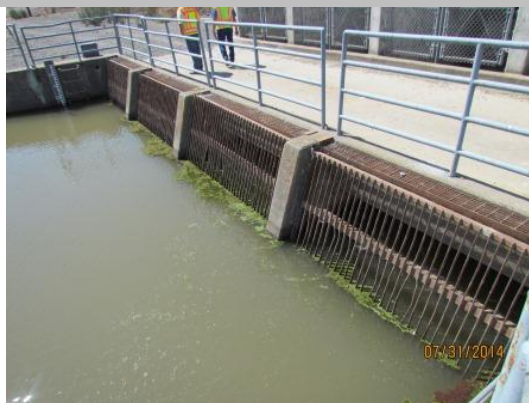
Photo 1 of 1 : ST_2014_NA0060_21_13_20140731_00017.jpg

Photo shows properly maintained trash racks.

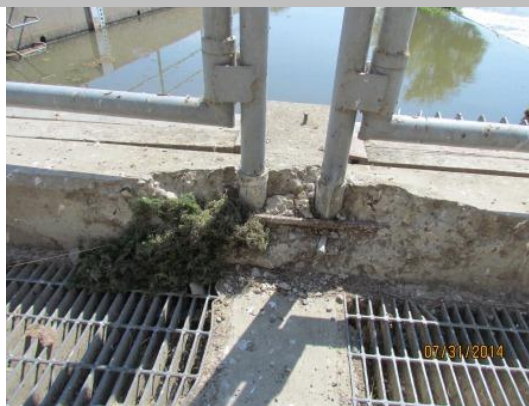
Photo 1 of 1 : ST_2014_NA0060_22_3_20140731_00012.jpg

View of the exposed rebar. LMA noted the deficiency and will repair by next inspection.

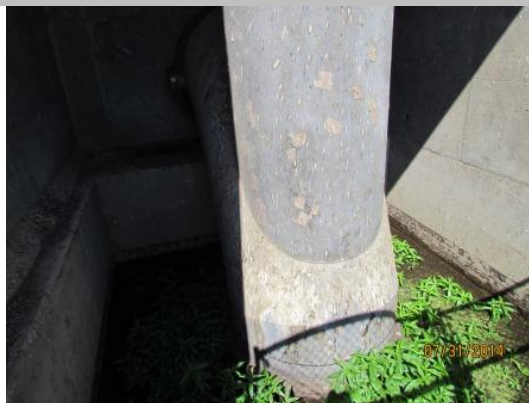
Photo 1 of 1 : ST_2014_NA0060_22_12_20140731_00018.jpg

Photo shows one sump with vegetation present.

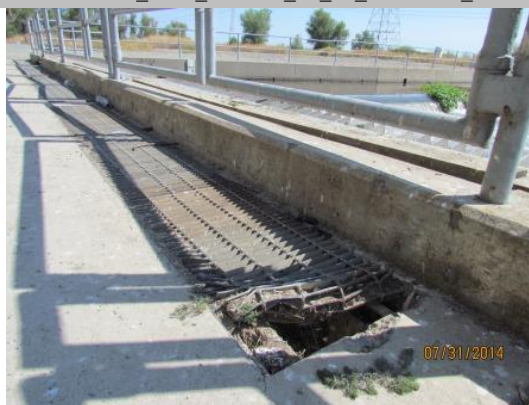
Photo 1 of 1 : ST_2014_NA0060_22_18_20140731_00021.jpg

View of the damaged grate.

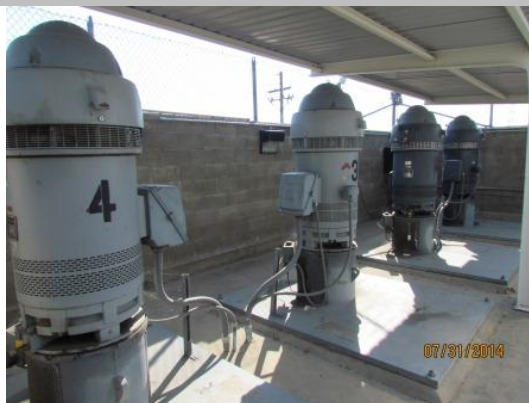
Photo 1 of 1 : ST_2014_NA0060_23_10_20140805_00013.jpg

Photo shows motors which appear to be maintained and in good working condition.

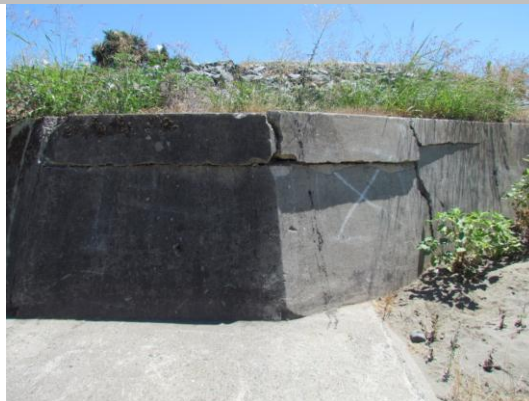
Photo 4 of 7 : ST_2014_NA0060_3_1_20140630_00002.jpg

Concrete cracking along the south wing wall.

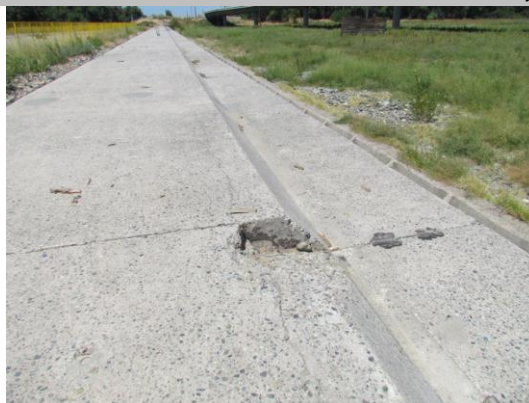
Photo 7 of 7 : ST_2014_NA0060_3_1_20140630_00007.jpg

Minor concrete spalling present.

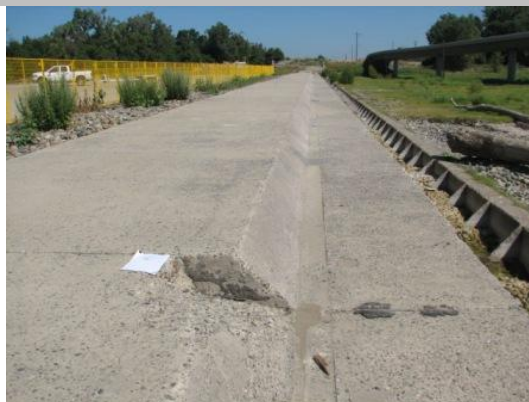
Photo 1 of 1 : ST_2014_NA0060_3_15_20140630_00010.jpg

This photo shows some surface damage.

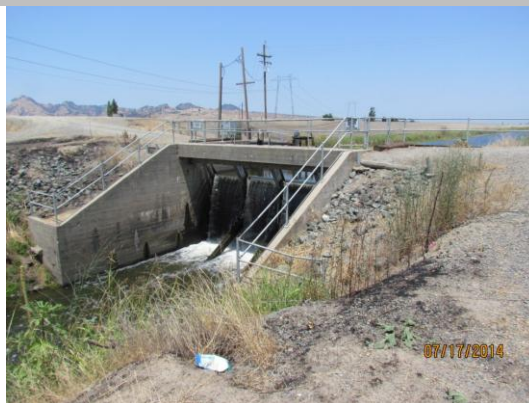
Photo 1 of 1 : ST_2014_NA0060_11_3_20140821_00003.jpg

View of the downstream side of the Wadsworth Canal Weir No.4 showing erosion along channel.
